MAINTENANCE DREDGING IN A SENSITIVE ENVIRONMENT
Case Study: Manchester Entrance Channel

Carlos G. Peña, P.E.¹

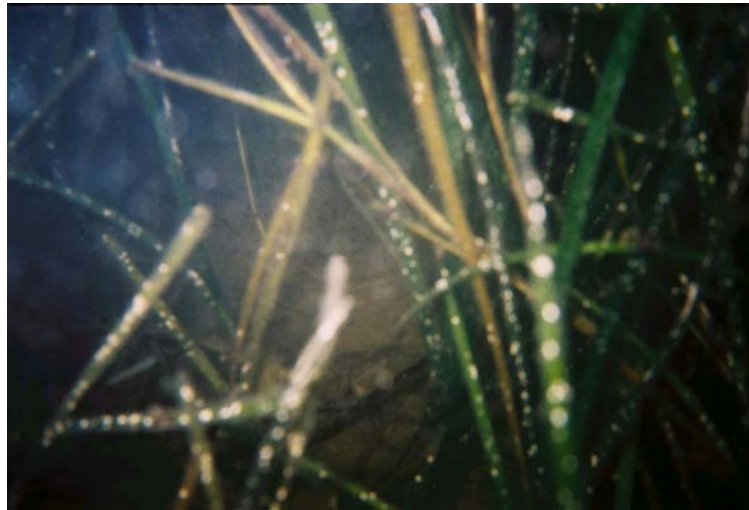
Typical Eelgrass Bed in New England (Photo 1)

In New England an eel grass habitat is usually found along protected bays and harbors in water depths ranging from $-1.0'$ below Mean Low Water to a depth exceeding $18'$ in the coastal regions in Manchester Harbor. According to Burkholder and Doheny (1968) eelgrass flourish when water temperatures range from 10°C to 20°C and a salinity range from 26 ppt to 42 ppt. Eelgrass is a deciduous marine plant commonly referred to seagrass, crabgrass and grass wrack. The plant produces roots, stems, leaves, flowers and seeds. The leaves typically grow from $12''$ to $48''$ depending on the habitat characteristics and photosynthesize carbon dioxide in seawater into oxygen. Eelgrass populations grow by reproduction and vegetative growth. Reproduction growth includes the maturation of pollen grains and ovaries, shedding of pollen into the water, pollination, fertilization and the formation of mature fruits with seeds (Burkholder & Doheny 1968). The vegetative growth includes the development from seed, turion and lateral bud formation, up to and including the production of flowering shoots with buds (Burkholder & Doheny 1968). The development cycle of a plant is typically three (3) years, beginning with the seedling and the formation of a terminal bud the first year, the growth of a flowering shoots and the lateral vegetative shoots the second year and the sprouting of rhizomes and geometrically expansion the third year. The plant is perennial and lives for many years.

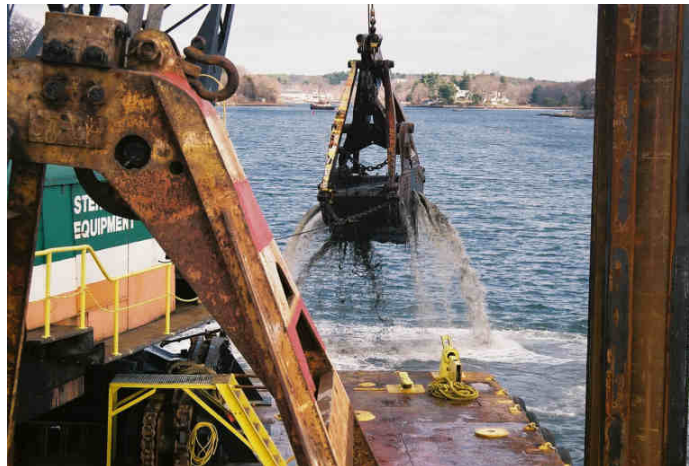
Clamshell dredge in the channel (Photo 2)

The dredging project was completed in the winter of 2001 by the contractor Jay Cashman, Inc. utilizing an eight (8) yard clamshell dredge and a 2000 cy dump scow (see Photo 2) with offshore disposal. The dredge area was limited to only specific areas and no dredging of the channel side-slopes. Additional restrictions included a no-spud zone within 25' of the buried sewer outfall line. The specifications also include the contractor to use a DGPS system with HYPACK software to provide positioning for the dredge and log dredge production activities. The contractor completed the work ahead of schedule and was very diligent in abiding by the permit conditions for the project.

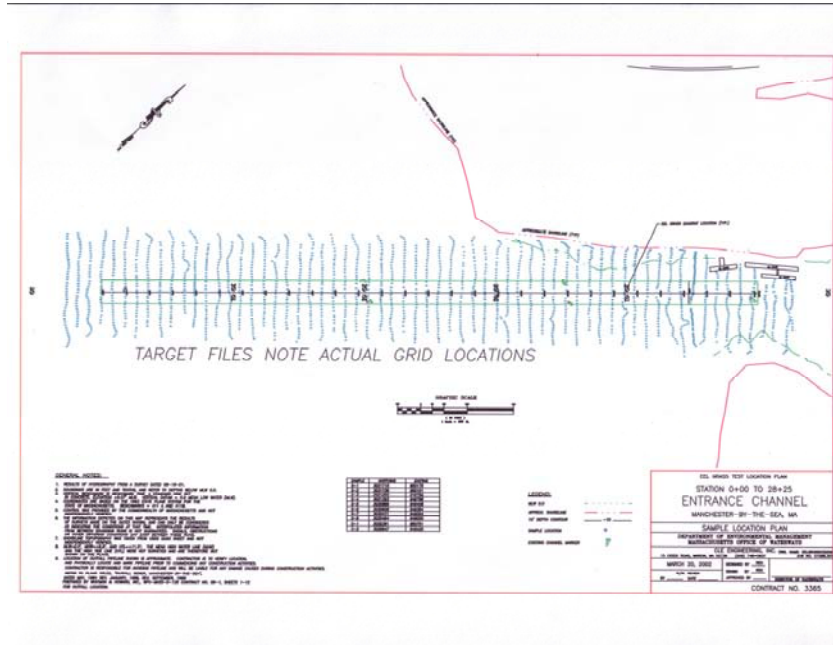
Eelgrass Study Locations (Plan 1)

At the completion of the dredging project, the NMFS required the Town to perform yearly eelgrass habitat inspections (see Plan 1) for a period of five (5) years. CLE Engineering, Inc. (CLE) is performing the studies under the supervision of our habitat specialist Jeffrey W. Oakes, P.E. The NMFS office conducted the initial pre-dredge evaluation of the project area and typically every fall during the middle of September and after the recreational boating seasons CLE's staff performs subsequent studies, prepares reports and submits them to the Town of Manchester-By-The-Sea.

On May 1, 2002, Carlos G. Peña, P.E., Jeffrey W. Oakes, P.E. and Robert Hollins, all of CLE, visited the site to perform a visual underwater site assessment of the eelgrass populations in the Entrance Channel. The assessment locations include eight (8) dredge targets in the channel and two (2) control targets outside the project area as shown on the attached plan by CLE dated March 20, 2002.

The results of the 2002 assessment are referenced to the locations in (Plan 1) and as tabulated below:

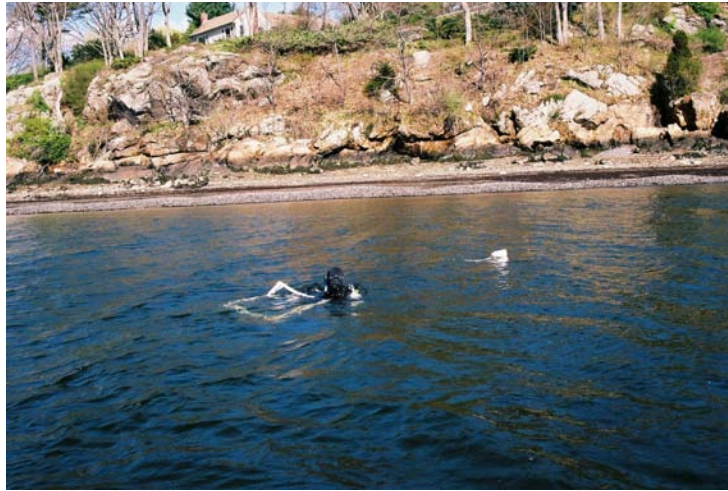
Diver Performing Eelgrass Inspection at Buoyed Location (Photo 3)

The August 16, 2001 CLE's pre-dredge survey confirmed eelgrass populations at target locations C-1, S-8, S-7, S-6, S-4 and near S-3 & S-1. The underwater eelgrass assessment was conducted by a P.E. diver utilizing scuba equipment with an underwater camera from our survey vessel (see Photo 3). The eelgrass studies are performed at ten (10) specific locations ranging in water depths from 10' to 18', eight (8) in the channel and two (2) control locations outside the channel area. The CLE team deploys ten (10) buoys at the locations using the DGPS system and then dives to each site and records the number, length and vitality of each representative eelgrass community. The assessment targets were located using DGPS positioned survey vessel and a buoy was placed at each location prior to diving activities. The diver dove at each assessment location, placed a one (1) meter grid on the seabed, photographed each referenced location and noted the density, length and color of eelgrass populations and a topside engineer recorded all data for this report. Presently we have completed three (3) studies and already trends are developing as the eelgrass community recovers from the dredging activity and repopulates the dredge area. Evidence prior to the dredging activity indicated the channel area made a complete recovery following past dredging projects and the installation of the said sewer outfall pipe. The preliminary results of the data so far show the eelgrass repopulating the channel areas. Equally spaced rhizome shoots sprouting and becoming denser once the initial plants establish themselves in a specific location characterize the migration of eelgrass plants across the channel.
