Maintenance Dredging in a Sensitive Environment
Case Study: Manchester Entrance Channel

By: Carlos G. Peña

CLE ENGINEERING, INC.

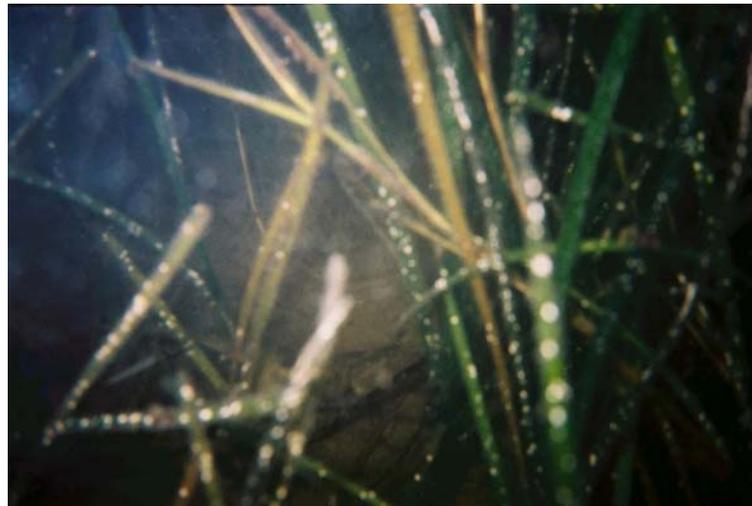
Typical Eelgrass Bed in New England (Photo 1)

In New England an eel grass habitat is usually found along protected bays and harbors in water depths ranging from -1.0' below Mean Low Water to a depth exceeding 18' in the coastal regions in Manchester Harbor. According to Burkholder and Doheny (1968) eelgrass flourish when water temperatures range from 10°C to 20°C and a salinity range from 26 ppt to 42 ppt. Eelgrass is a deciduous marine plant commonly referred to seagrass, crabgrass and grass wrack. The plant produces roots, stems, leaves, flowers and seeds. The leaves typically grow from 12" to 48"

depending on the habitat characteristics and photosynthesize carbon dioxide in seawater into oxygen. Eelgrass populations grow by reproduction and vegetation. Reproduction growth includes the maturation of pollen grains and ovaries, shedding of pollen into the water, pollination, fertilization and the formation of mature fruits with seeds (Burkholder & Doheny 1968). The vegetative growth includes the development from seed, turion and lateral bud formation, up to and including the production of flowering shoots with buds (Burkholder & Doheny 1968). The development cycle of a plant is typically three (3) years, beginning with the seedling and the formation of a terminal bud the first year, the growth of a flowering shoots and the lateral vegetative shoots the second year and the sprouting of rhizomes and geometrically expansion the third year. The plant is perennial and lives for many years.

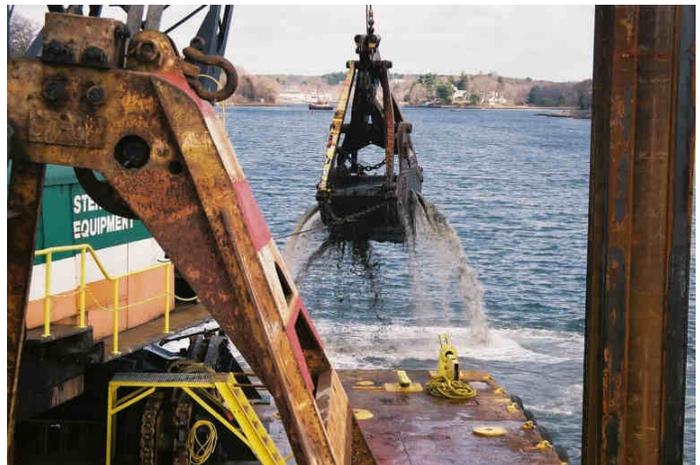
Clamshell dredge in the channel (Photo 2)

The dredging project was completed in the winter of 2001 by the contractor Jay Cashman, Inc. utilizing an eight (8) yard clamshell dredge and a 2000 cy dump scow (see Photo 2) with offshore disposal. The dredge area was limited to only specific areas and no dredging of the channel side-slopes. Additional restrictions included a no-spud zone within 25' of the buried sewer outfall line. The specifications also include the contractor to use a DGPS system with HYPACK software to provide positioning for the dredge and log dredge production activities. The contractor completed the work ahead of schedule and was very diligent in abiding by the permit conditions for the project.

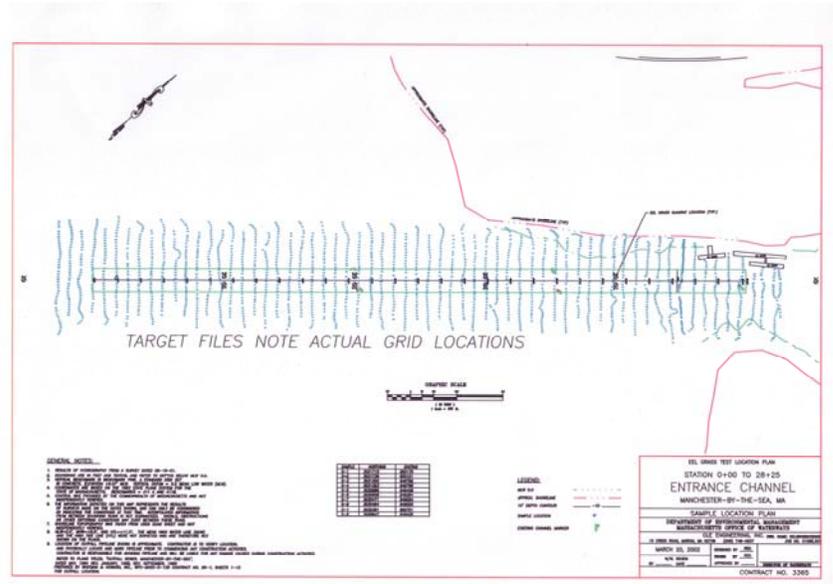
Eelgrass Study Locations (Plan 1)

populations in the Entrance Channel. The assessment locations include eight (8) dredge targets in the channel and two (2) control targets outside the project area as shown on the attached plan by CLE dated March 20, 2002.

At the completion of the dredging project, the NMFS required the Town to perform yearly eelgrass habitat inspections (see Plan 1) for a period of five (5) years. CLE Engineering, Inc. (CLE) is performing the studies under the supervision of our habitat specialist Jeffrey W. Oakes, P.E. The NMFS office conducted the initial pre-dredge evaluation of the project area and typically every fall during the middle of September and after the recreational boating seasons CLE's staff performs subsequent studies,

The results of the 2002 assessment are referenced to the locations in (Plan 1) and as tabulated below:

The results of the 2003 assessment are referenced to the locations in (Plan 1) and as tabulated below:

The results of the 2004 assessment are referenced to the locations in (Plan 1) and as tabulated below:

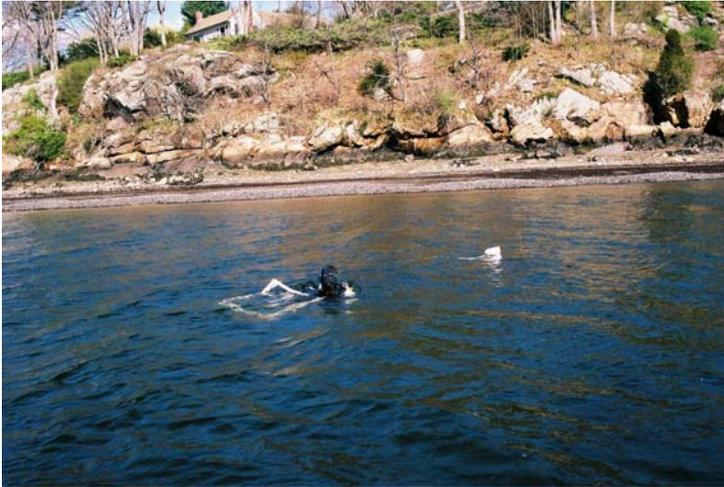
Diver Performing Eelgrass Inspection at Buoyed Location (Photo 3)

The August 16, 2001 CLE's pre-dredge survey confirmed eelgrass populations at target locations C-1, S-8, S-7, S-6, S-4 and near S-3 & S-1. The underwater eelgrass assessment was conducted by a P.E. diver utilizing scuba equipment with an underwater camera from our survey vessel (see Photo 3). The eelgrass studies are performed at ten (10) specific locations ranging in water depths from 10' to 18', eight (8) in the channel and two (2) control locations outside the channel area. The CLE team deploys ten (10) buoys at the locations using the DGPS system and then dives to each site

and records the number, length and vitality of each representative eelgrass community. The assessment targets were located using DGPS positioned survey vessel and a buoy was placed at each location prior to diving activities. The diver

dove at each assessment location, placed a one (1) meter grid on the seabed, photographed each referenced location and noted the density, length and color of eelgrass populations and a topside engineer recorded all data for this report. Presently we have completed three (3) studies and already trends are developing as the eelgrass community recovers from the dredging activity and repopulates the dredge area. Evidence prior to the dredging activity indicated the channel area made a complete recovery following past dredging projects and the installation of the said sewer outfall pipe.
